SUBJECT: Looseness or Play in Front Seat

MODELS: E36

00 50 364 CORRECTING PLAY IN SEAT HEIGHT
ADJUSTMENT

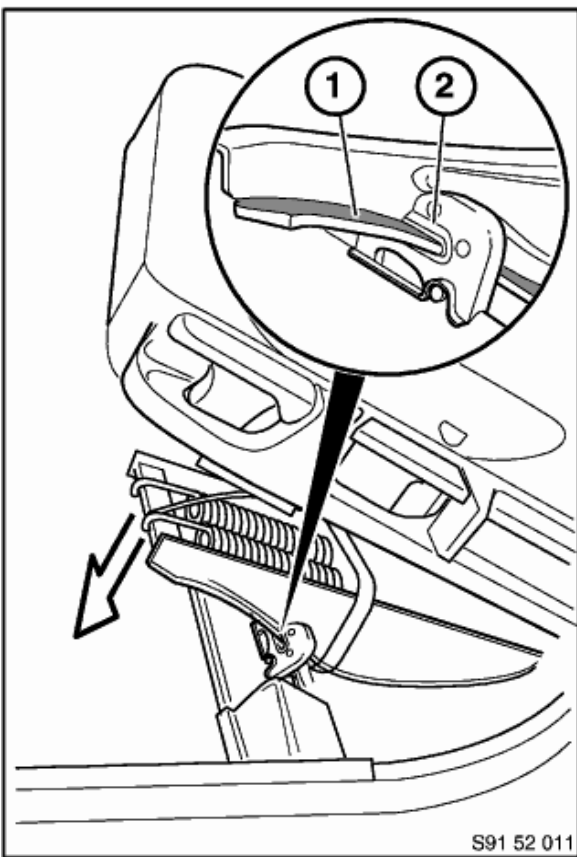
Situation: Some seats may exhibit excessive play at the contact point between the sliders and guides for the height adjustment. This play may lead to complaints of the seat wobbling, or excessive backrest play.

Press down on seat frame firmly and measure play between slider (2) and guide (1) using a 5/1 00 mm feeler gage blade.

Apply Special Tool 52 1 200 on outside slider. Tighten nut (1) to 24 Nm.

Conform with tightening torque steps. Excessive torque would lead to seizure of the seat height control.

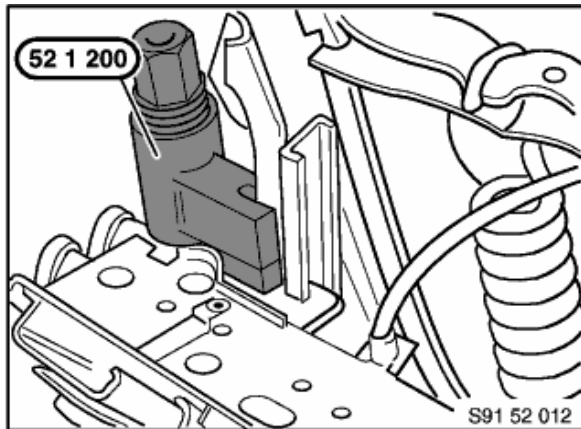
Play > 5/100 mm:

Apply special tool again and tighten nut (1) with an additional 2 Nm torque. Keep repeating this step until the play is < 5/100 mm.
