SUBJECT: Oxygen Sensor Wiring Harness Voluntary Recall Campaign No. 98A02

MODEL: E36 with M42 engine (manual transmission only)

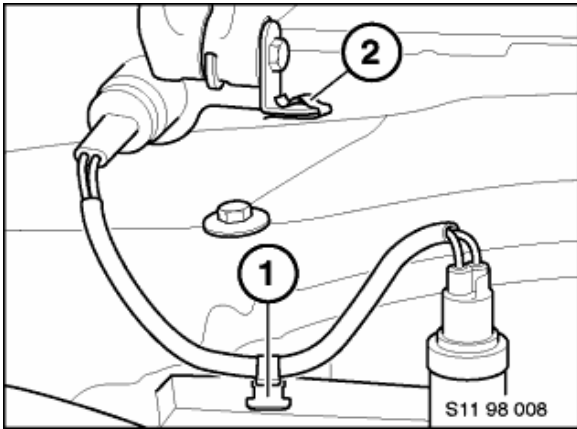
The oxygen sensor harness may have been mistakenly secured with clips to the exhaust heat shield and/or to a bracket on the transmission housing.

Due to the movement between the vehicle body, transmission and exhaust system the oxygen sensor harness may stretch and break over time causing the check engine light to illuminate and a fault code 70, (oxygen sensor disconnected) to set in the DME.

- Troubleshoot and repair DME fault codes other than fault code 70 using the DIS tester instructions as necessary. (Note: Other DME fault code repairs are covered under the terms of the BMW Emissions and New Car Limited Warranties.)
- Check the oxygen sensor harness for hold down clips or any signs (crimped or pinched areas in the sheathing) where a clip or other hold down device may have been installed in the past.
The illustration below shows possible areas where the harness may be fastened with clips: (1) clip on exhaust heat shield, (2) bracket on transmission.

- Remove all clips from the exhaust heat shield, transmission bracket and any other oxygen sensor wiring harness hold down devices (wire ties, etc.).
- If installed, bend the transmission bracket (1) using a pair of pliers up over the bolt head as shown in the illustration below.

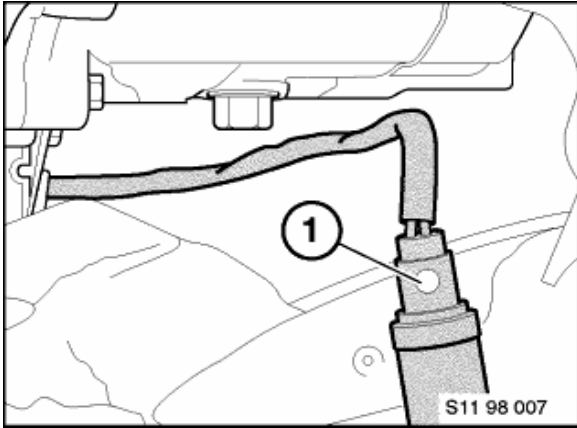
- the oxygen sensor harness had any type of fastener (clip, bracket, wire tie, etc.) holding it in place, or
- the oxygen sensor harness sheathing shows any signs (crushed or crimped areas) where it may have been held down / fastened in the past, or

- fault code 70, (oxygen sensor disconnected) is stored in the DME.
Install the new oxygen sensor (1) if necessary, routing the wiring harness as shown in the illustration below. The harness should not contact any other components when routed correctly.
Do not use any hold down clips, wire ties, etc. to fasten the harness.
